Maidstone (Holy Trinity) Conservation Area

Character Appraisal

Maidstone Borough Council
Approved 02nd October 2007

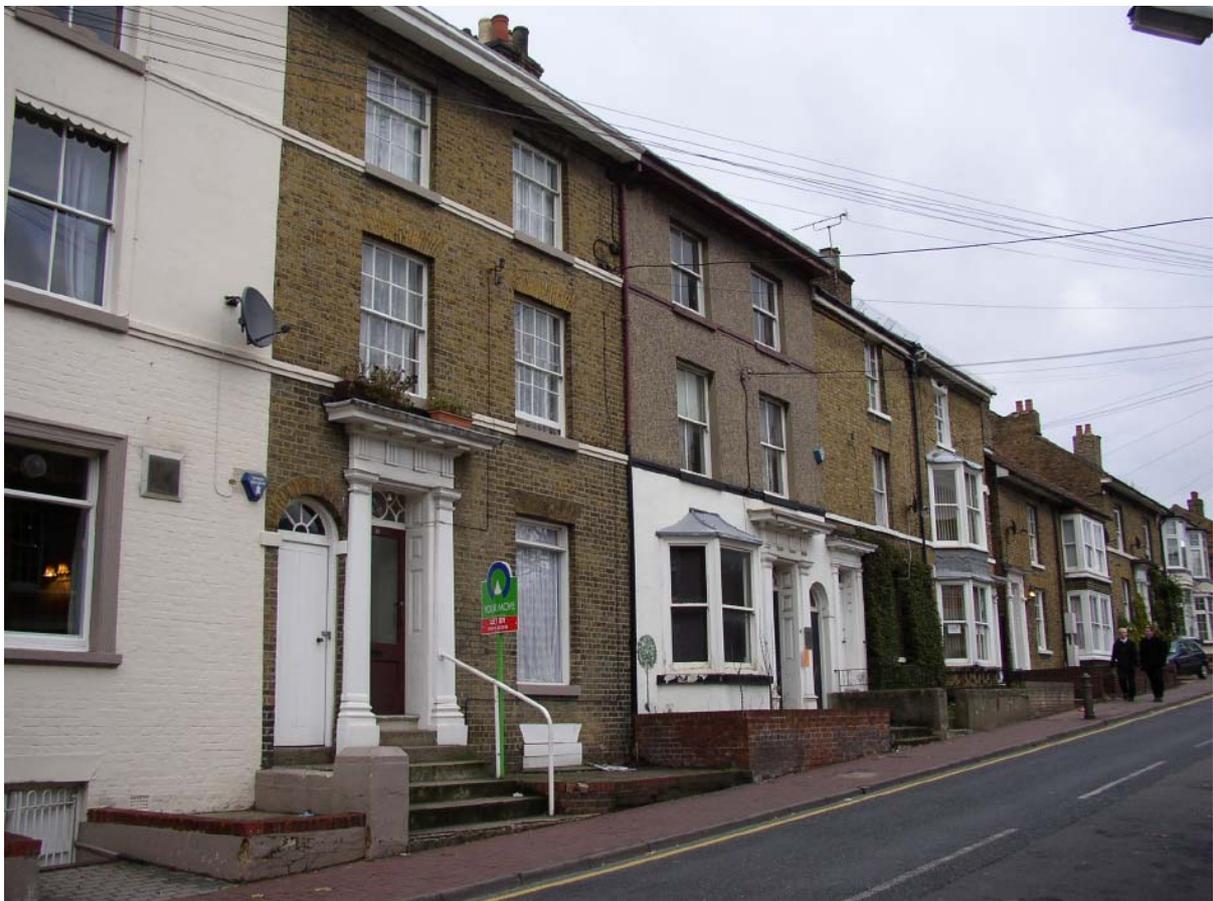
Brewer Street runs in an entirely straight line from its junction with Week Street to that with Wheeler Street, rising steadily all the way. Views along the street towards the east are closed and deflected by the old British School building of 1823 on the opposite side of Wheeler Street; as the junction with Week Street is a crossroads views in this direction are closed by the mature trees in Brenchley Gardens. The southern side of the street suffers from a lack of enclosure in its mid section caused by the demolition of four cottages and the creation of a car park (with an ugly height-barrier at its entrance) and by the set back of the modern community hall attached to the rear of the Methodist Church in Union Street. Mature trees in the old burial ground running between Brewer Street and Union Street are prominent in views along Brewer Street where they help to define the line of the street and are features of major townscape importance.

Only the mid-section of Brewer Street is currently within the Conservation Area. A case might be made for the Conservation Area to be extended to include the eastern end of the street right up to its junction with Wheeler Street, which includes characterful small terraced houses all built prior to 1848; a smaller extension might be justified in the other direction to include some fine later 19th Century buildings. However, the case for such extensions would need to be examined in more detail by further survey work.

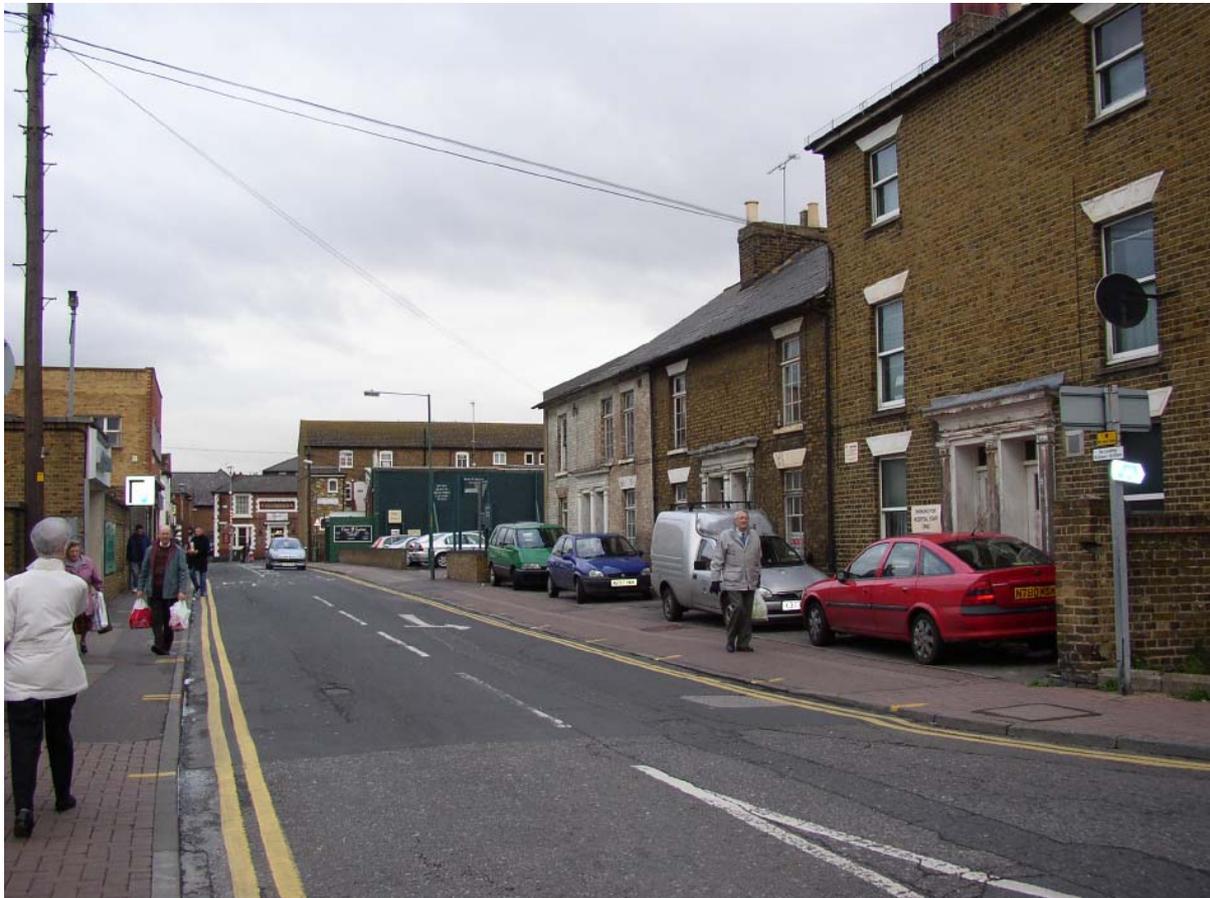
The northern section, from Union Street to the junction with Wyke Manor Road, is the least satisfactory section in townscape terms. In part this is due to modern changes, but the road could never have been entirely visually satisfying. This is because it was built close up to the rear boundaries of the burgage plots of properties in Week Street, and thus could never be properly developed on its western side. The 1848 Ordnance Survey plan shows this side of the street to be in the form of open yards and outbuildings, and this character remains to this day. The east side of the street developed soon after its construction with closely-spaced semi-detached houses at the north end and terraced houses to the south.

With the loss of some of these houses circa 1970 the character of this part of the street was further weakened and matters are not helped by the views of the tall block of Colman House and its unsightly car park building which dominate views to the south and by the views opened up of the uncoordinated extensions at the rear of the Ophthalmic Hospital. Views to the north are more satisfactorily terminated by the pleasant early 19th Century building of the Duke of Marlborough public house in Union Street.

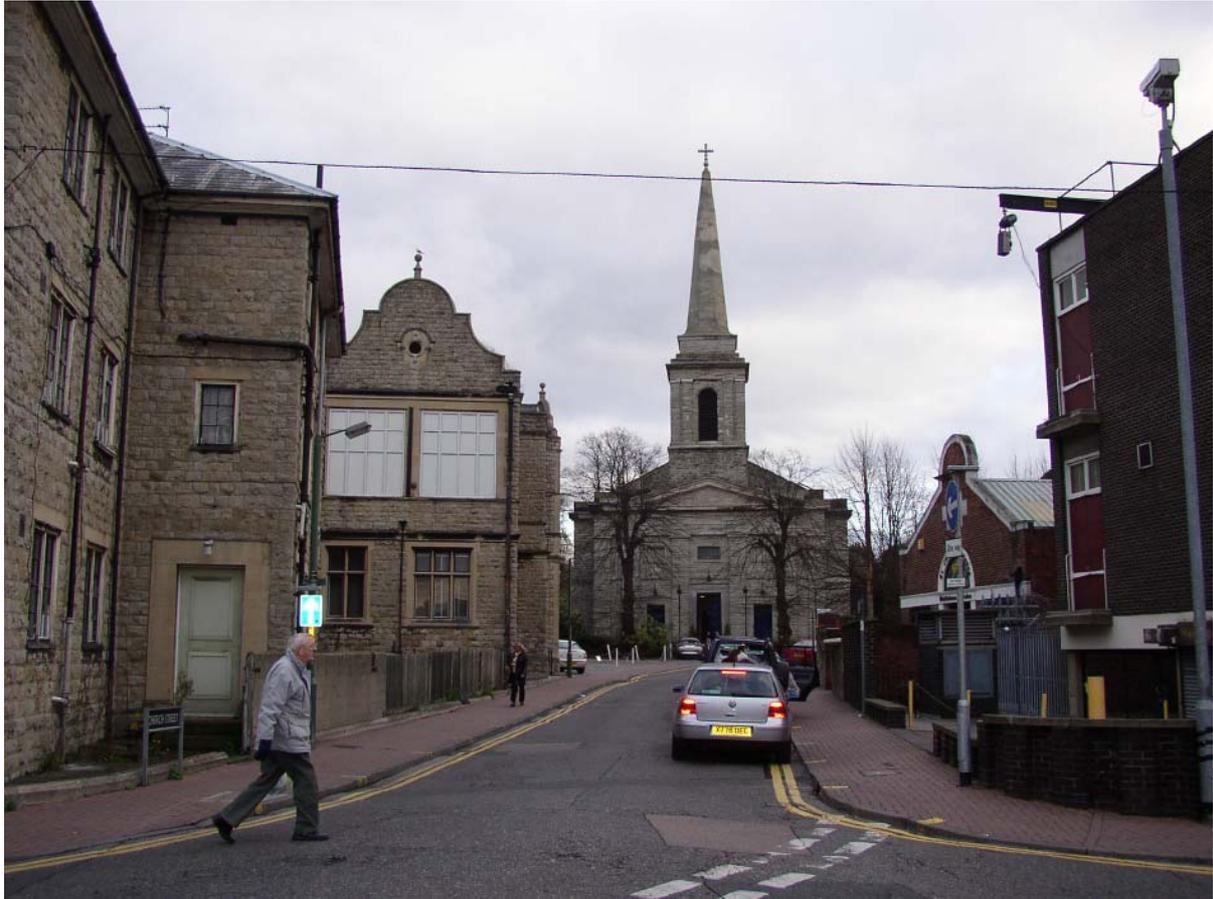
The relative poverty of the townscape in this part of Church Street makes the abrupt change on turning the corner into the central section of the street all the more effective. For on turning the corner the view of the west front of Holy Trinity is suddenly revealed, its imposing architectural composition dominating the space and forming an excellent example of a planned townscape. The widening of the road to form a forecourt to the church emphasises the formality of the space and results in a more static than kinetic character – a place to pause and admire the architecture. The space is flanked to the north by the fine buildings of the Ophthalmic Hospital, arranged so as to emphasise the triangular forecourt to the church. The south side, however, remained undeveloped as it fell within the rear gardens of properties in King Street and is therefore less satisfactory, although a ragstone wall on the back edge of the pavement is important in providing some degree of enclosure in an attractive form. Ragstone is the dominant building material in this section of the street in contrast to brick in other sections. The mature trees fronting Holy Trinity Church are also major positive elements in the townscape here and are protected by a Tree Preservation Order as are other trees in the churchyard. The fine qualities of this space have been compromised in recent years by the encroachment onto it of forecourt car parking associated with the ophthalmic hospital and the reclamation of this space when the hospital is brought back into use will be important.

The street then squeezes past the south-western corner of the church continuing the side of the triangle before turning sharply to the right to run down to King Street. Lion House, on the corner of Church Street and Marsham Street, partially closes the view before this turn, preventing views along the length of Marsham Street. The southern limb of Church Street developed on this eastern side immediately after construction, but the western side was not built upon until the 1860s. The view down the hill to King Street is closed by the half-timbered façade of the listed building at 50 King Street, although this itself is overshadowed to the sides and rear by modern shopping developments. The bulk of the multi-storey car park at the junction of Church Street and King Street is also detrimental to the character of the Conservation Area. Looking up Church Street from King Street the flank wall of Holy Trinity Church closes the view.

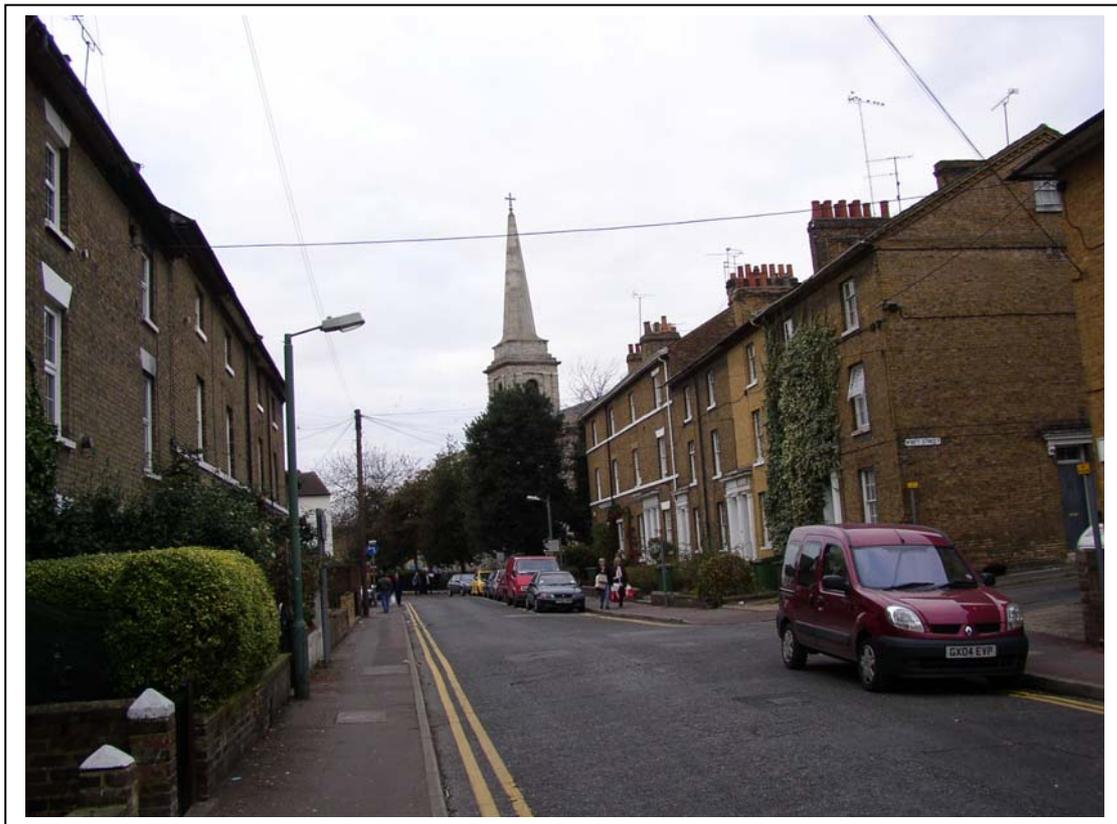
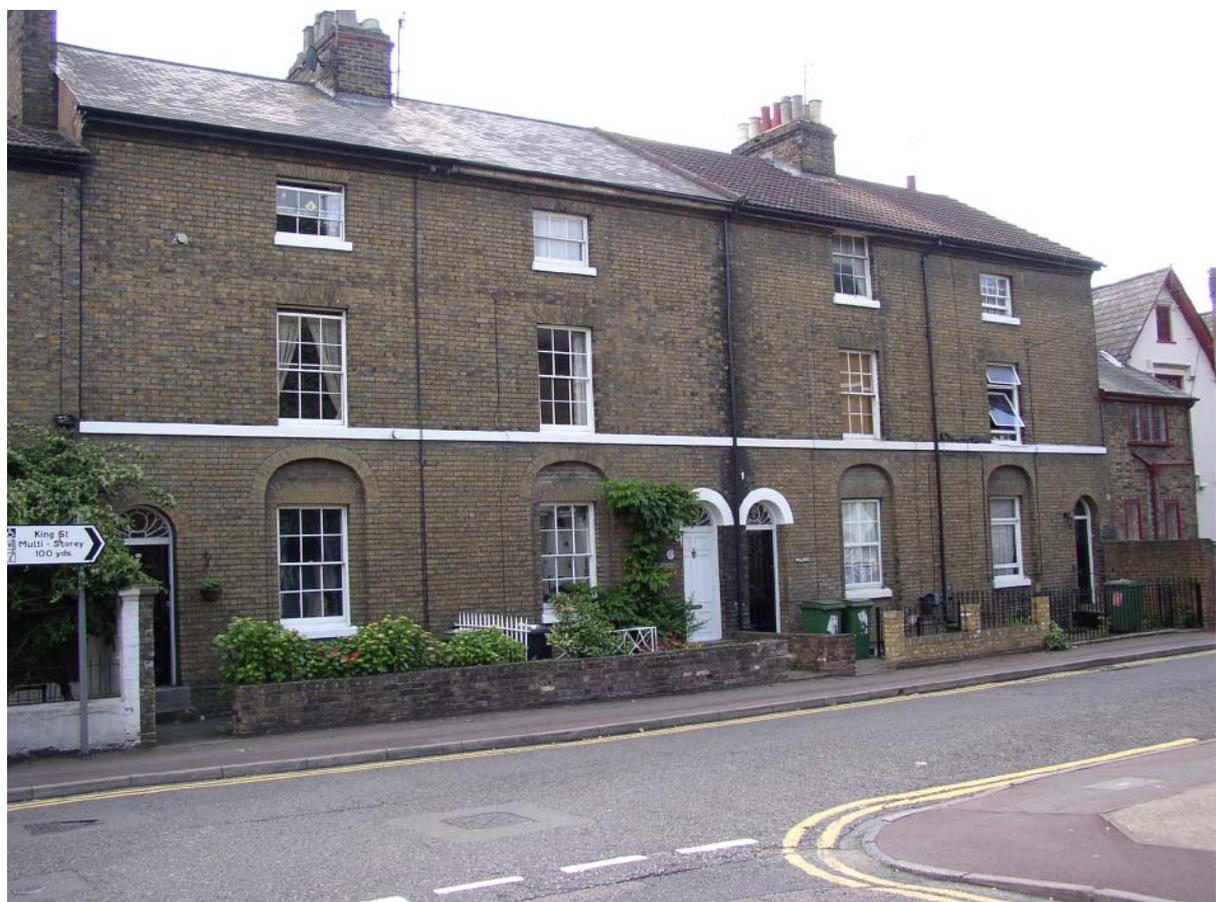
Marsham Street was laid out in the early 1830s and development appears to have been fairly rapid. The 1848 Ordnance Survey Plan shows it to be fully developed with the exception of the large plot later occupied by the Howard de Walden Institute.

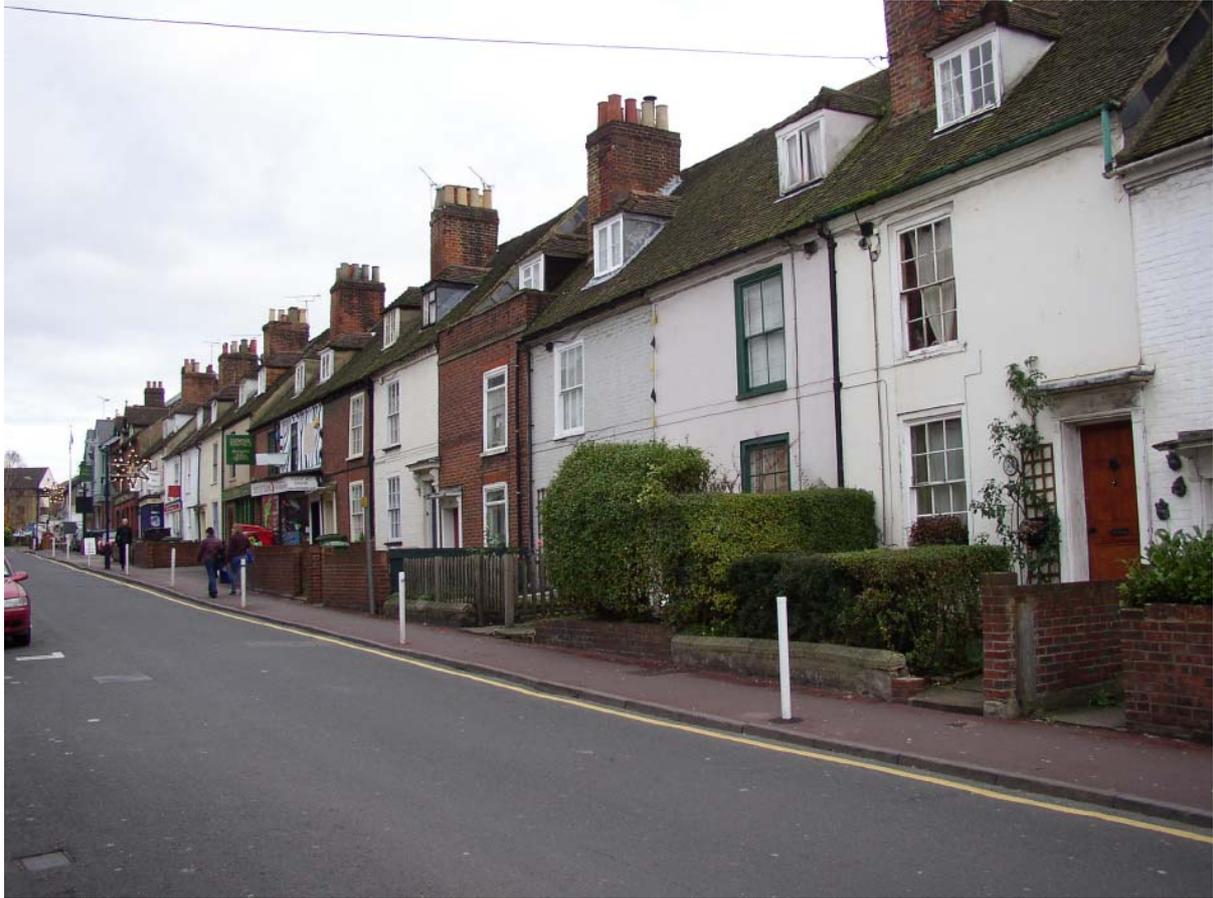
Union Street originated as a lane, probably in medieval times, but was not developed before 1800. It was, however, the earliest street within the Conservation Area to be developed, and is of more mixed character than most other streets. It rises gently from its junction with Week Street and at its mid point, just before its junction with Wyatt Street and the Conservation Area boundary, bends gently to the south. The result of this is that the hinge-point on the outer side of this bend becomes a focal point in views in either direction; it is therefore unfortunate that this site is occupied by an 8 storey block of flats erected circa 1970 set back from the street line. However, in mitigation, trees planted on its grassy forecourt are now assuming some importance in the townscape.
